MARTIN COUNTY COURTHOUSE

DOMES + ROOF REPAIR UPDATE

June 2021

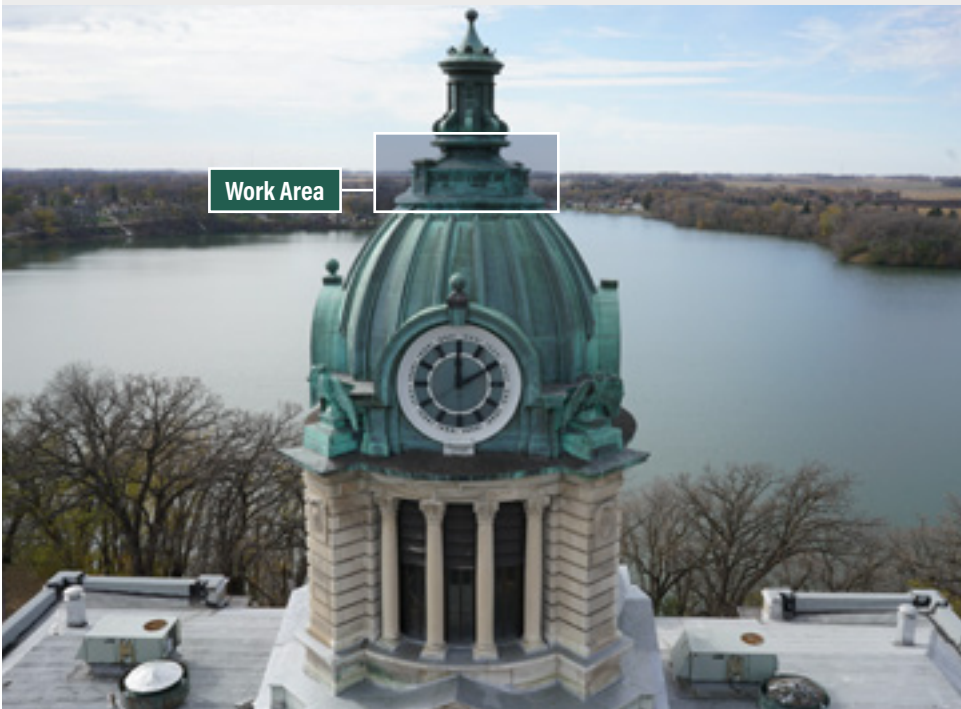
June work focused on the detailed work area identified in the photo below.

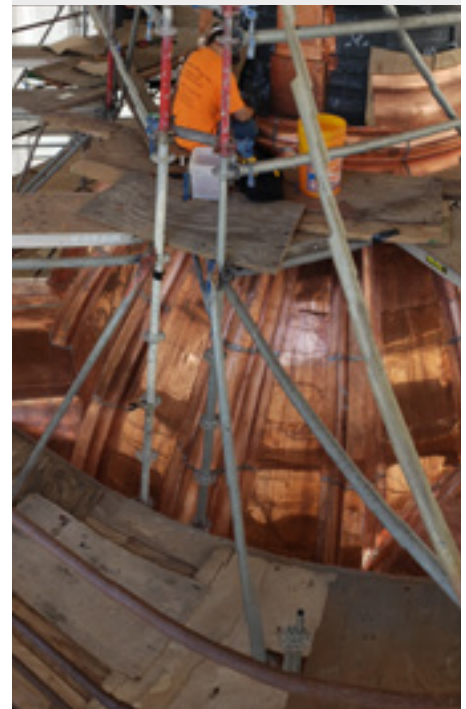
Major and minor ribs are completed at the base of the lantern.

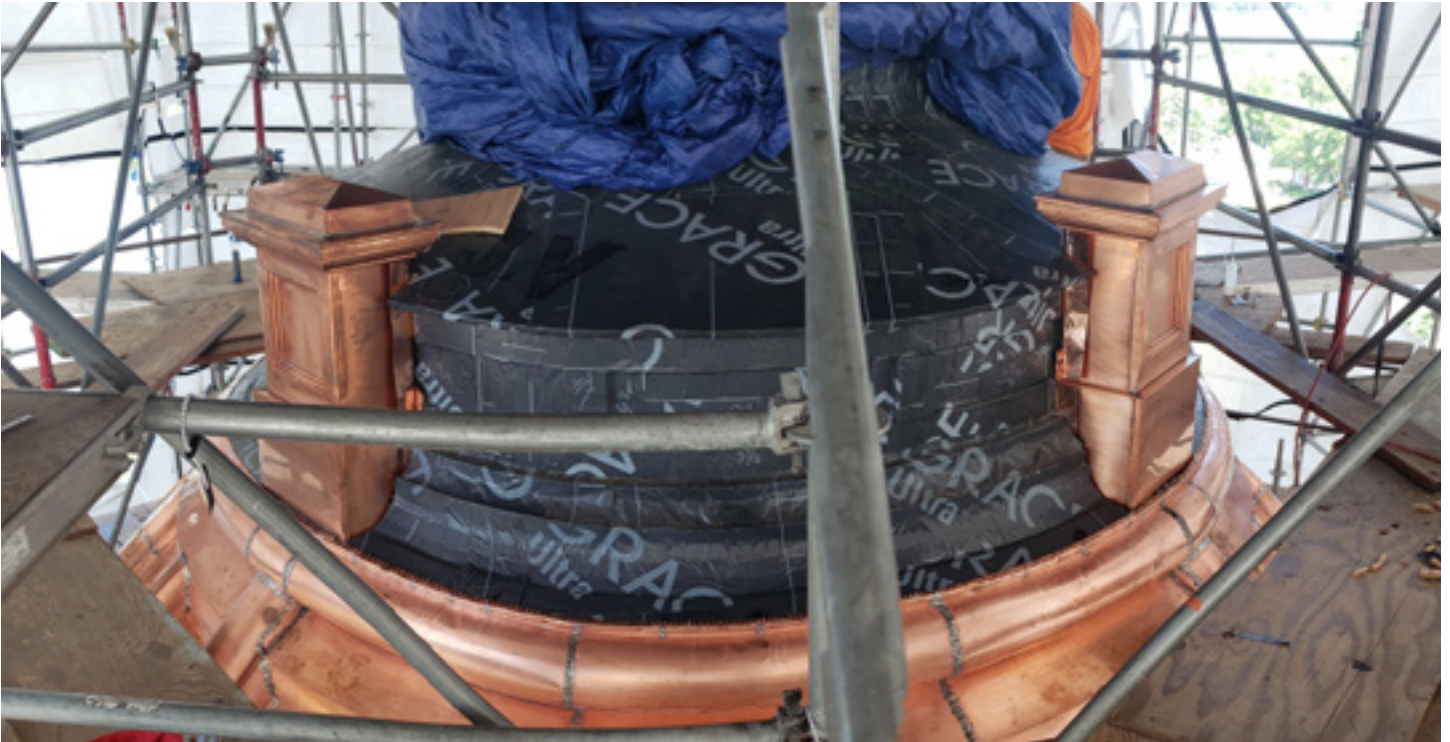
New copper trim is applied to the base of the lantern.

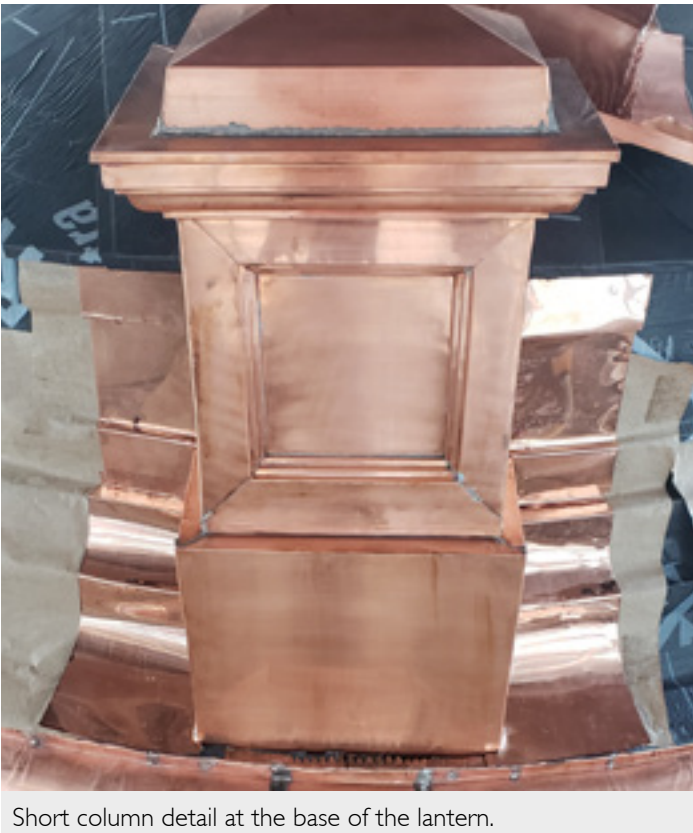
Short columns at the base of the lantern are being set and soldered in place.
